# Seagrass snapshot: Leschenault Estuary 2020–21

Through the Healthy Estuaries WA program, the condition and area of seagrass is being monitored in five South West estuaries, including Leschenault Estuary. This snapshot provides an update of the distribution of seagrass in Leschenault Estuary in February 2021.

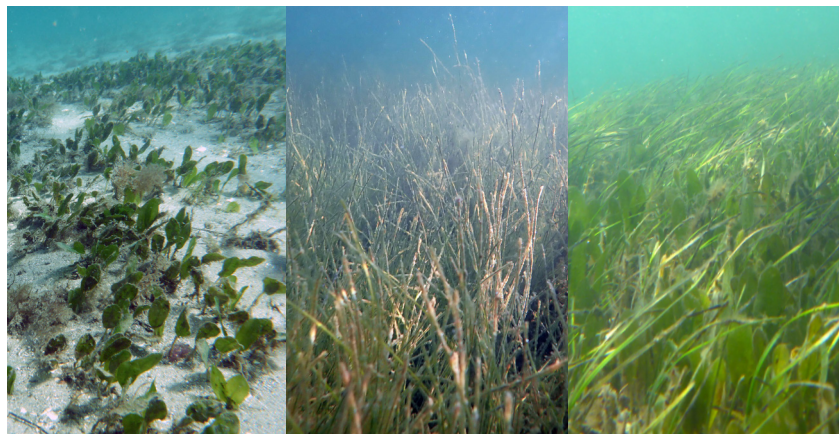
Three species of seagrass occur in the Leschenault Estuary. *Halophila ovalis* (left image) is dominant, and is generally found throughout the estuary basin. *Ruppia megacarpa* (centre image) is often observed along the eastern shoreline. *Zostera muelleri* (right image) is found near the Cut, where the waters are more marine.

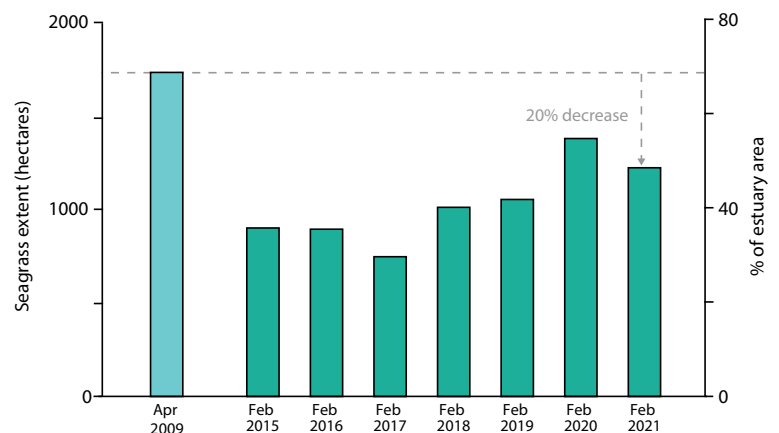
- In the 1980s and '90s, seagrass was widely distributed in the estuary, particularly in the northern area, and absent only in a small area of deep water in the centre of the estuary.
- In April 2009, seagrass extended across 1,741 hectares – about 69 per cent of the estuary area.
- In 2014, there was a substantial loss of seagrass, which prompted monitoring to start in 2015.
- Seagrass is slowly recovering but is yet to return to the extent reached in 2009.

The Department of Water and Environmental Regulation has monitored seagrass annually from 2015 to 2021. Seagrass distribution was estimated to be only 37 per cent of the estuary area in 2015, but this has increased to nearly 50 per cent in recent years. Additionally, in 2020, seagrass had begun to recolonise the northern estuary, which hasn’t been observed in the area since 2009.

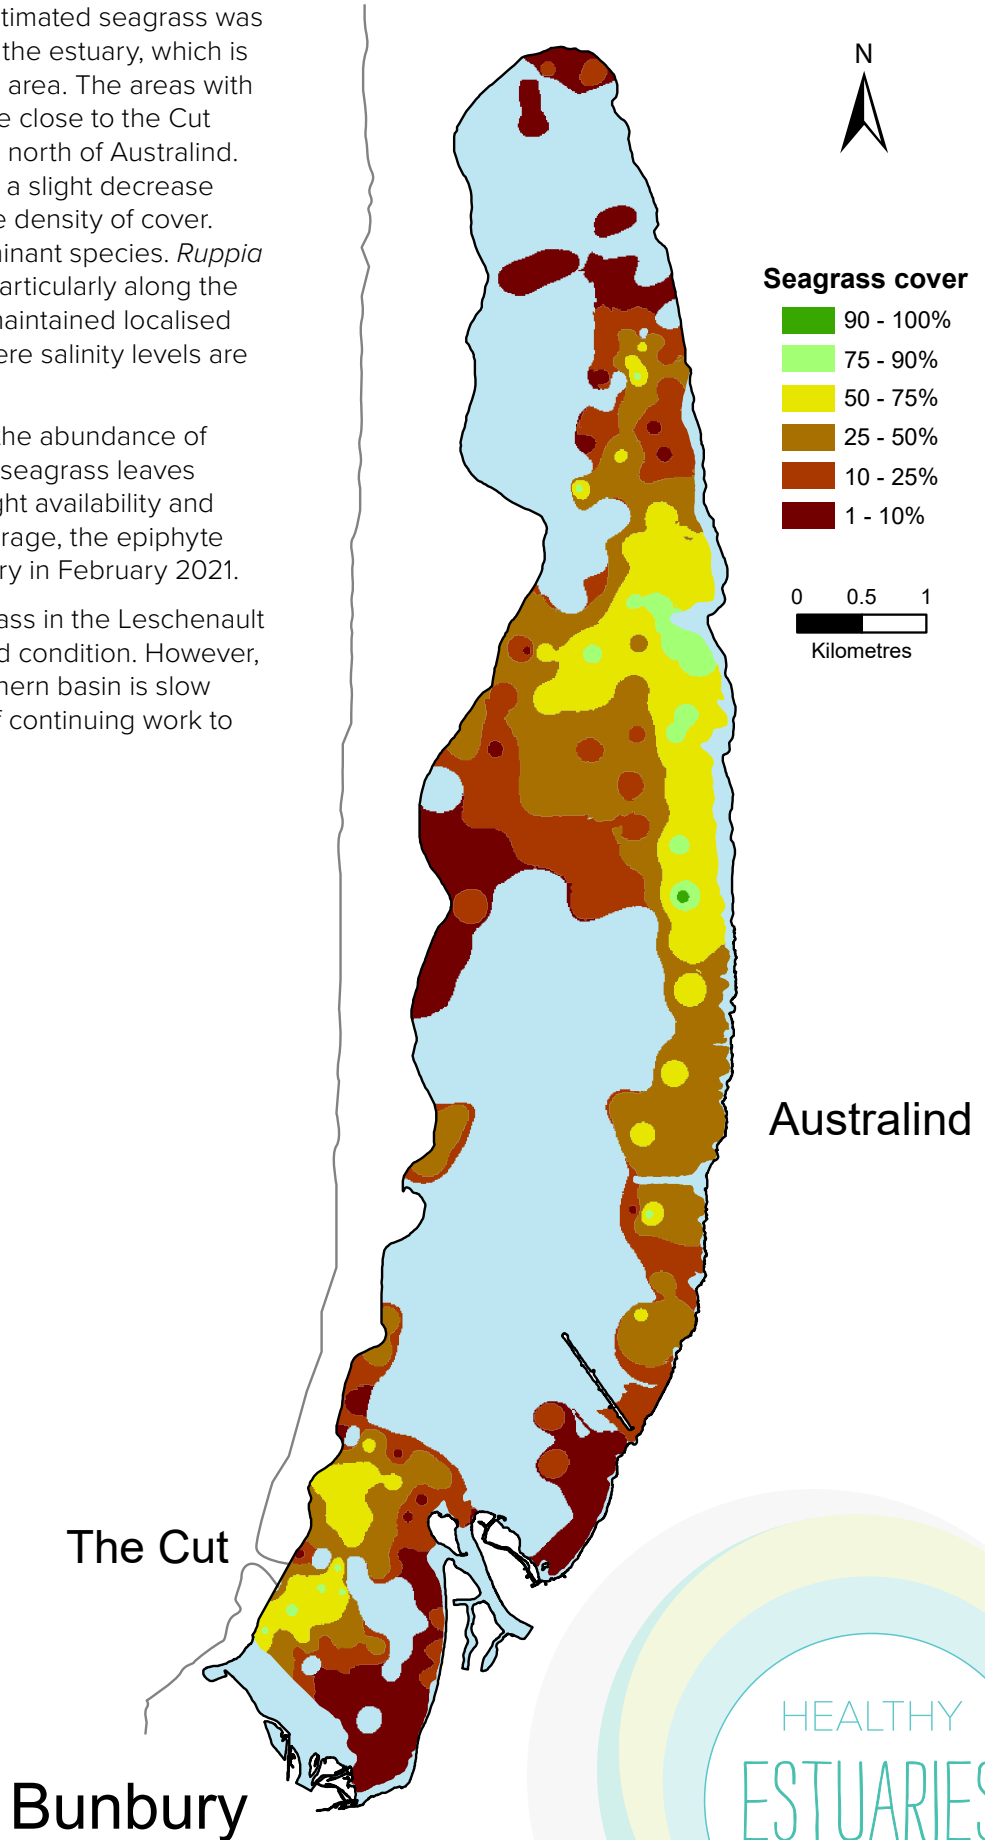
In early 2021, the department estimated seagrass was spread across 1,229 hectares of the estuary, which is about 49 per cent of the estuary area. The areas with the densest seagrass cover were close to the Cut and along the eastern shoreline, north of Australind. Compared with 2020, there was a slight decrease in the extent of seagrass and the density of cover. *Halophila* remains the most dominant species. *Ruppia* continues to expand its range, particularly along the eastern shoreline. *Zostera* has maintained localised distribution close to the Cut, where salinity levels are most stable.

The department also observed the abundance of small organisms growing on the seagrass leaves (epiphytes), which can reduce light availability and impact seagrass growth. On average, the epiphyte cover was high across the estuary in February 2021.

Overall, in February 2021, seagrass in the Leschenault Estuary was in a stable and good condition. However, recovery of seagrass in the northern basin is slow and highlights the importance of continuing work to improve water quality.
