Seagrass snapshot: Oyster Harbour 2020–21

Through the Healthy Estuaries WA program, the condition and area of seagrass are being monitored in five South West estuaries, including Oyster Harbour. This snapshot provides an update on the distribution of seagrass in Oyster Harbour in January 2021.

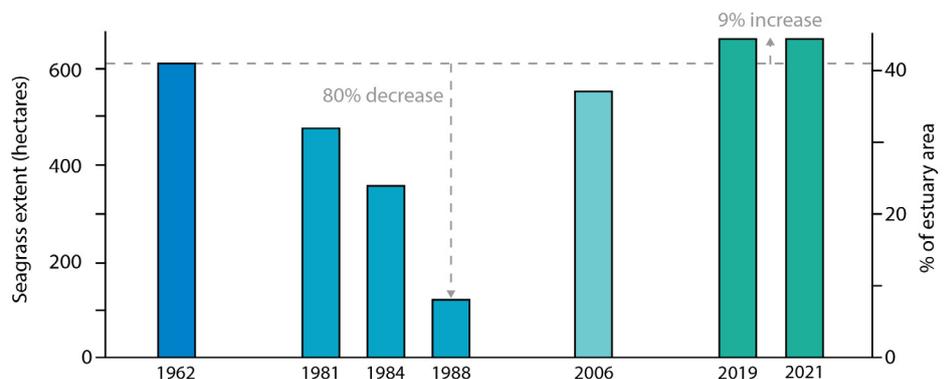
- In 1962, seagrass was distributed across 610 hectares.
- About 80 per cent of seagrass was lost in 1988 because of light reduction and excess nutrients, which promoted epiphyte growth.
- By 2006, seagrass recovered to span across 560 hectares, or 40 per cent of the estuary area.
- In 2019, seagrass had further recovered, extending across 663 hectares, or 50 per cent of the estuary area (nine per cent more than what was recorded in 1962).

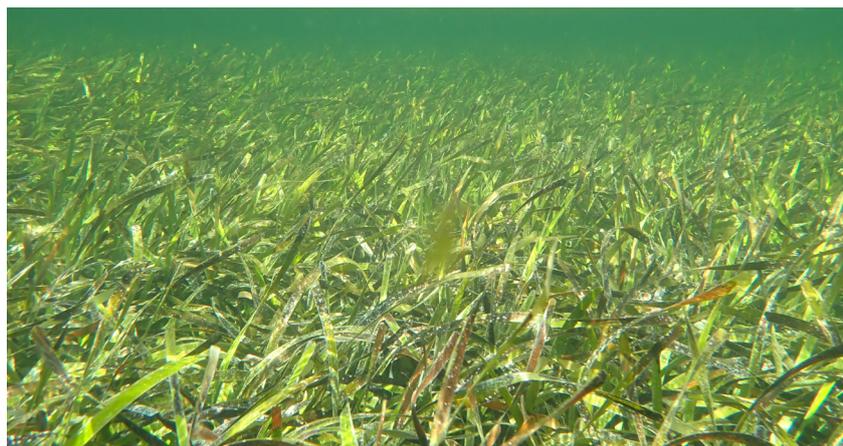
Seagrass distribution in January 2021

The extent of seagrass meadows in 2021 is consistent with 2019, improving slightly from about 663 hectares in 2019 to 665 in 2021. The highest-density meadows were found along the southern bank near Johnson Cove and in the central basin. *Posidonia australis* is found throughout the estuary, while *Posidonia sinuosa* is mostly found in the lower half of the harbour. In 2021, seagrass canopy height was typically around 50 cm, but ranged from 10 to 100 cm.
